# Road Safety Audit – Ellesmere

<b>Stage:</b>	<b>1</b>
<b>Location:</b>	<b>Scotland Street and Canal Way, Ellesmere, Shropshire</b>
<b>Site:</b>	<b>Proposed additional arm to existing roundabout, right turn lane at existing signalled junction, and cycle link at new development access</b>
<b>ATSS Ref:</b>	<b>231201</b>
<b>Client Ref:</b>	<b>2314</b>
<b>Date:</b>	<b>23 February 2024</b>

<b>Report Title:</b>	<b>Stage 1 road safety audit, Ellesmere</b>
<b>Date:</b>	<b>23 February 2024</b>
<b>Document reference and revision:</b>	<b>231201 V2</b>
<b>Prepared by:</b>	<b>Avon Traffic &amp; Safety Services Ltd</b>
<b>On behalf of:</b>	<b>Highgate Transportation Ltd</b>

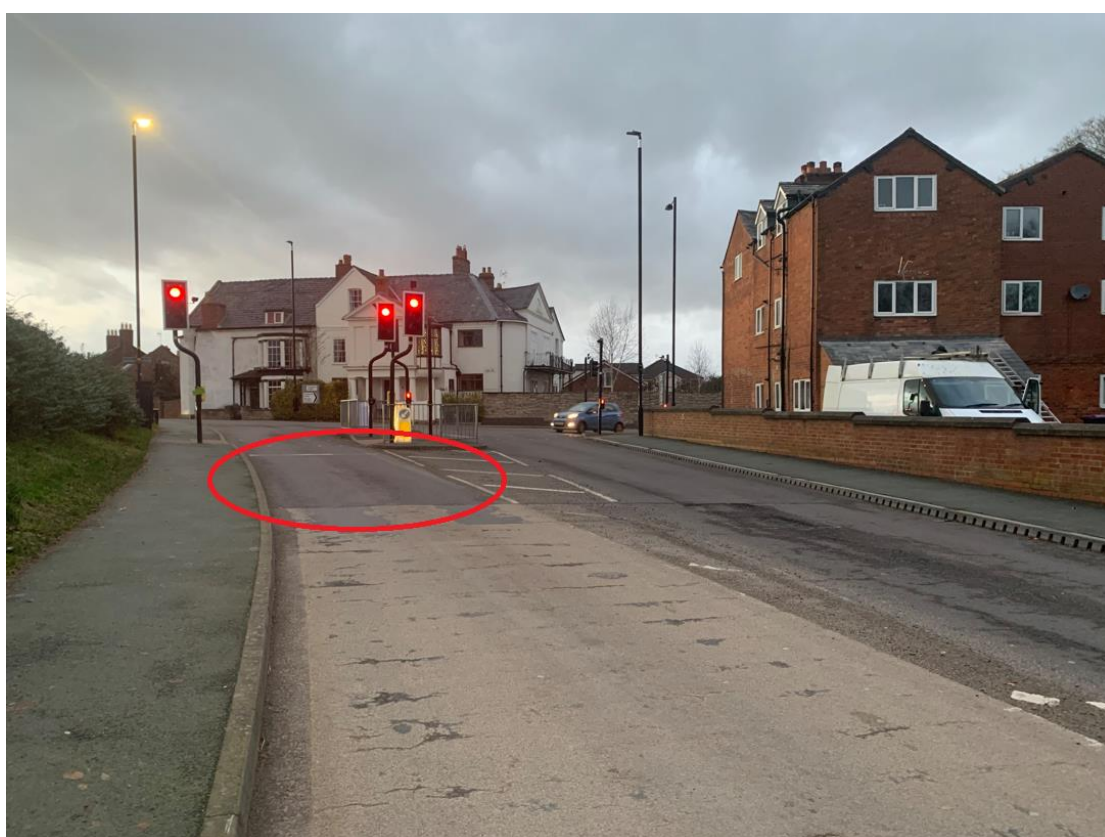
*Looking north along Canal Way towards the signalised junction with the A495. The existing high friction surfacing does not extend to the stop line (circled) following previous surfacing*

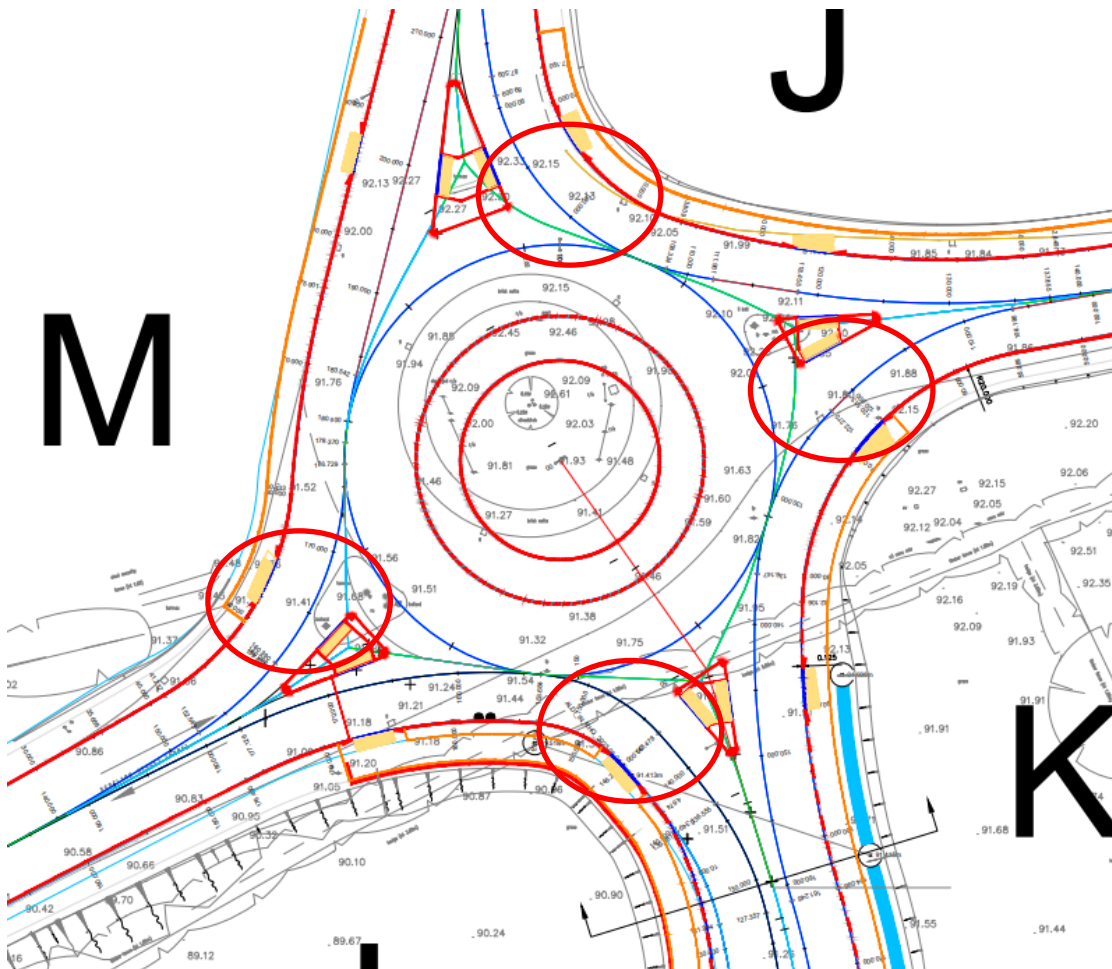
**Location** – All arms at Ellesmere Business Park roundabout

**Summary** – Risk of vehicle conflicts due to lack of driver guidance

The proposals include a two-lane entry on all approaches to the new roundabout however all exits are to be single lane. Without adequate provision to accommodate all manoeuvres, particularly along the A495 arms which are the busiest, the current design encourages conflict and may result in driver confusion and vehicle collisions at the exit points

*The current two-lane entry single-lane exit design may increase conflicts and confusion to drivers*

**Recommendation** – Ensure that all approaches are well signed, and drivers are provided with sufficient information to assist them in making the correct lane decision when approaching and negotiating the new roundabout

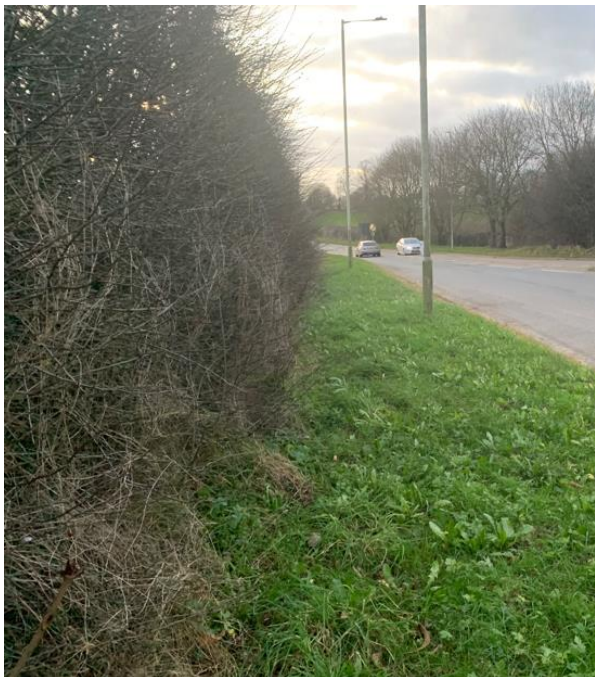
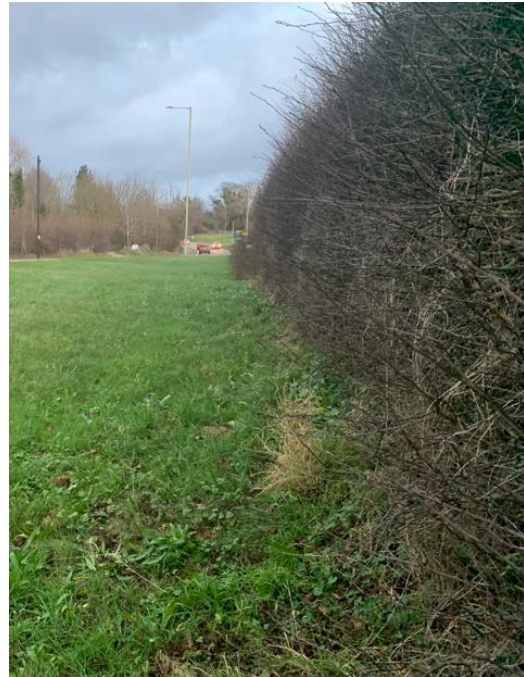
**Location** – Ellesmere Business Park roundabout, south arm

**Summary** – Risk of vehicle side-swipe or junction overshoot type collisions due to inadequate visibility

The new south arm is proposed to be installed by removing part of an existing hedgerow. No information has been submitted to the audit team showing that the hedgerow on either side will be removed/relocated so that sightlines are kept clear of obstruction. If sightlines are obstructed by the existing hedgerow or other features, they may result in side-swipe or junction overshoot type collisions

*Looking left (west) and right (east) at the proposed south roundabout arm – Sections of this hedgerow would need to be removed to establish adequate visibility*

**Recommendation** – Arrange for significant sections of the existing hedgerow to be permanently removed and keep the verge to the east and west clear of any other obstructions to ensure that visibility for drivers approaching the roundabout from the new south arm is always clear

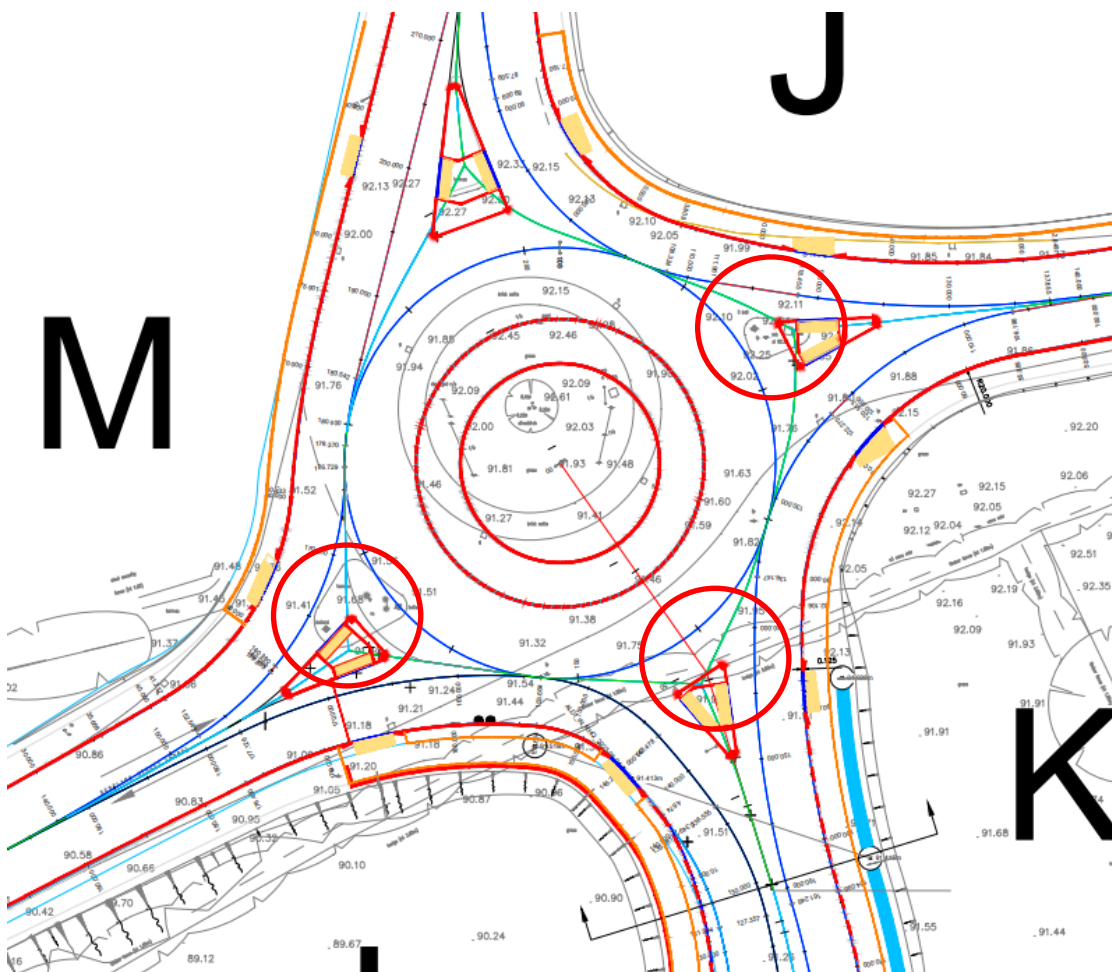
**Location** – Proposed splitter islands on the south, east and west arms at Ellesmere Business Park roundabout

**Summary** – Risk of driver confusion and loss of control or rear-end shunt type collisions due to lack of driver information

Due to the location of the tactile paving slabs the new splitter islands appear to have insufficient room to incorporate reflective bollards or direction signs at their front end. Lack of reflective bollards may result in drivers striking the islands as they negotiate the roundabout in poor visibility conditions. The absence of direction signage may cause confusion to some drivers who may suddenly brake or change direction resulting in loss of control or rear-end shunt type collisions

*The proposed splitter islands appear to be too small to accommodate upright reflective bollards or direction signs*

**Recommendation** – Ensure that bollards and direction signage can be accommodated within the new roundabout layout

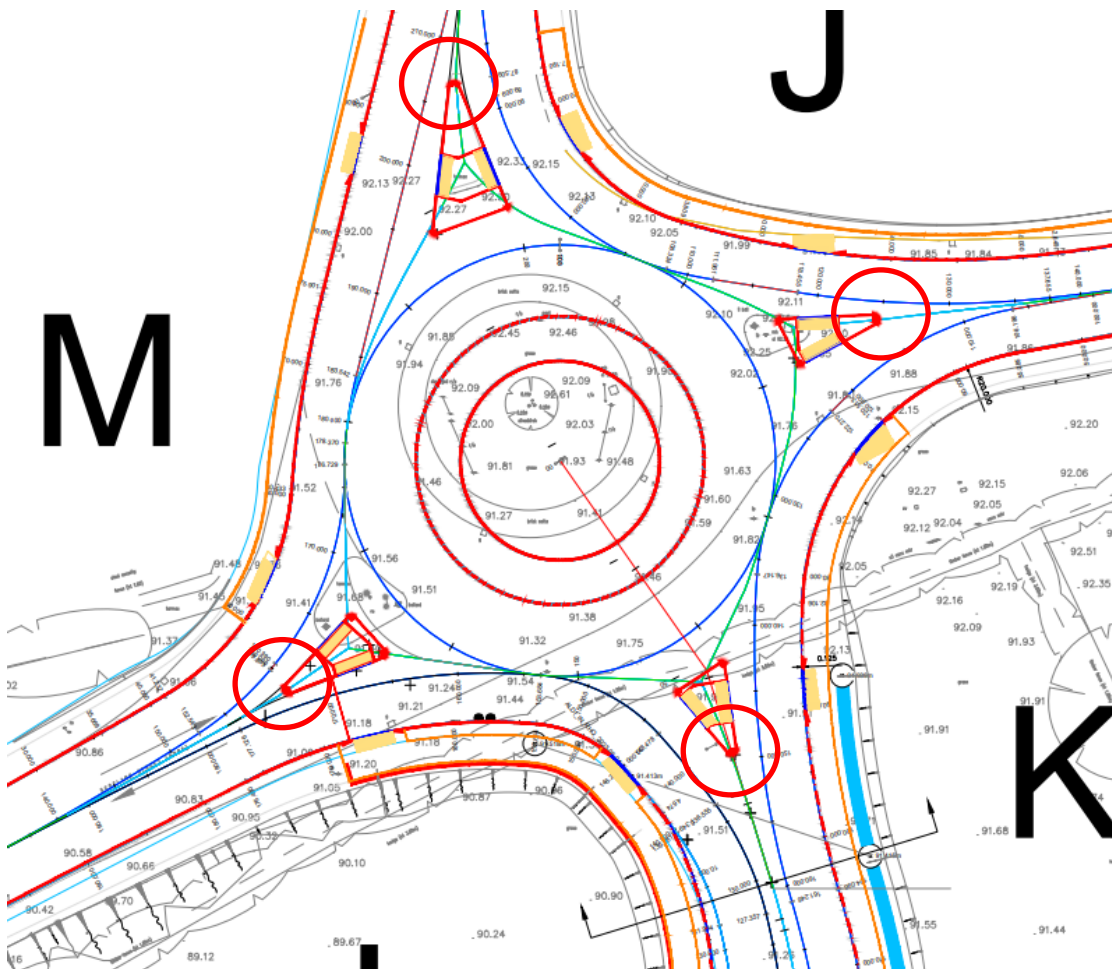
**Location** – Splitter islands on all arms of Ellesmere Business Park roundabout

**Summary** – Risk of head-on type collisions due to lack of ‘keep left’ bollards

The new and modified splitter islands do not include upright bollards or any other infrastructure to guide approaching traffic away from them and onto the correct path before entering the roundabout. Lack of such infrastructure may result in drivers striking the islands during periods of poor visibility and losing control of their vehicles or entering the roundabout on the incorrect side and colliding head-on with oncoming traffic

*Bollards on each approach to the roundabout would highlight the presence of the splitter islands ahead*

**Recommendation** – Ensure that suitable signing infrastructure is included in the proposed roundabout modifications to prevent collisions at the approaches to the roundabout

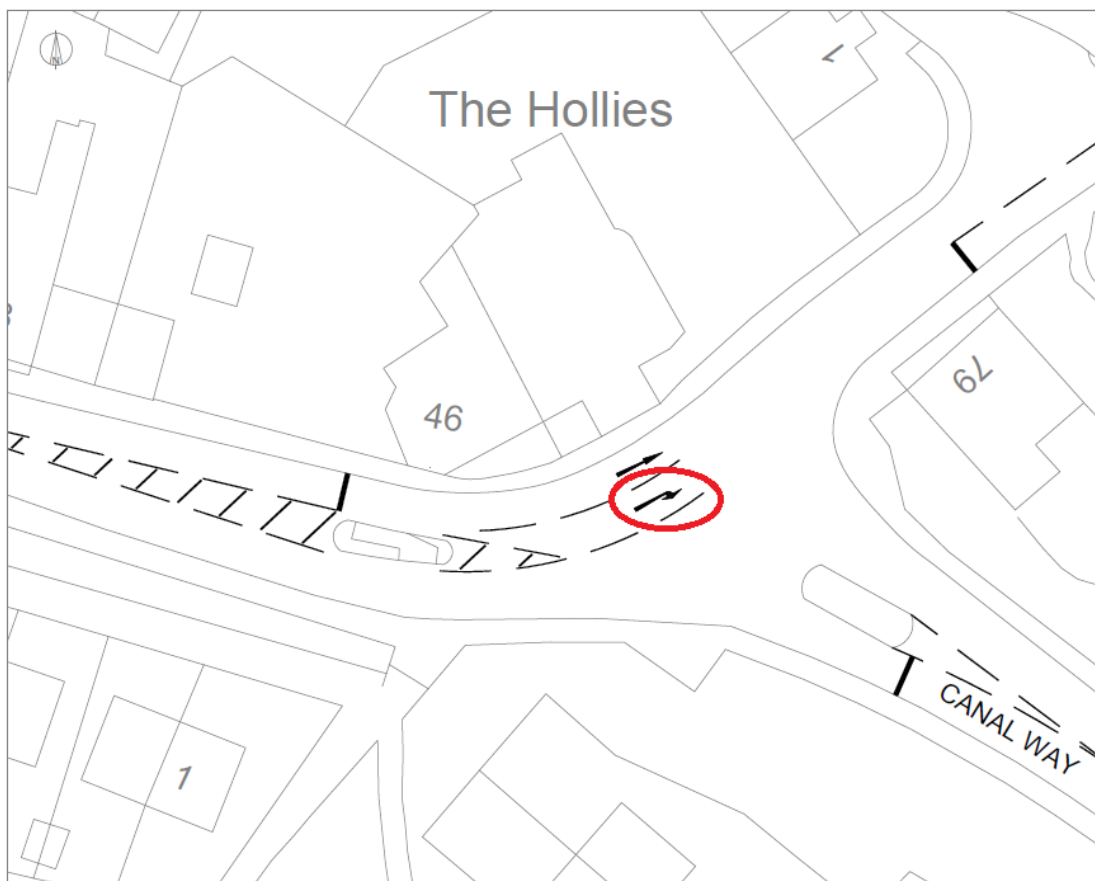
**Location** – Scotland Street/Canal Way junction

**Summary** – Risk of head-on and rear-end shunt type collisions due to lack of space for opposing vehicles to pass each other

The current arrangement at this three-arm junction facilitates each approach to operate independently in three different stages. In order to allow the junction to operate within capacity once the new development site is complete, it is proposed to combine the eastbound and westbound A495 stages into one stage and to provide a 'holding area' within the centre of the junction for vehicles turning right from the westbound A495 onto Canal Way. The right turn holding area appears to be in the path of oncoming traffic and in the lack of any tracking information the auditors are concerned that this proposal will cause conflict between those turning right and those approaching from the east resulting in head-on or rear-end shunt type collisions

*Vehicles in the proposed right turn lane waiting to turn into Canal Way may conflict westbound traffic*

**Recommendation** – Undertake swept path analysis of the proposed layout to make sure that vehicles, particularly HGVs can access and ensure that the modifications to the existing junction layout do not result in vehicle conflicts

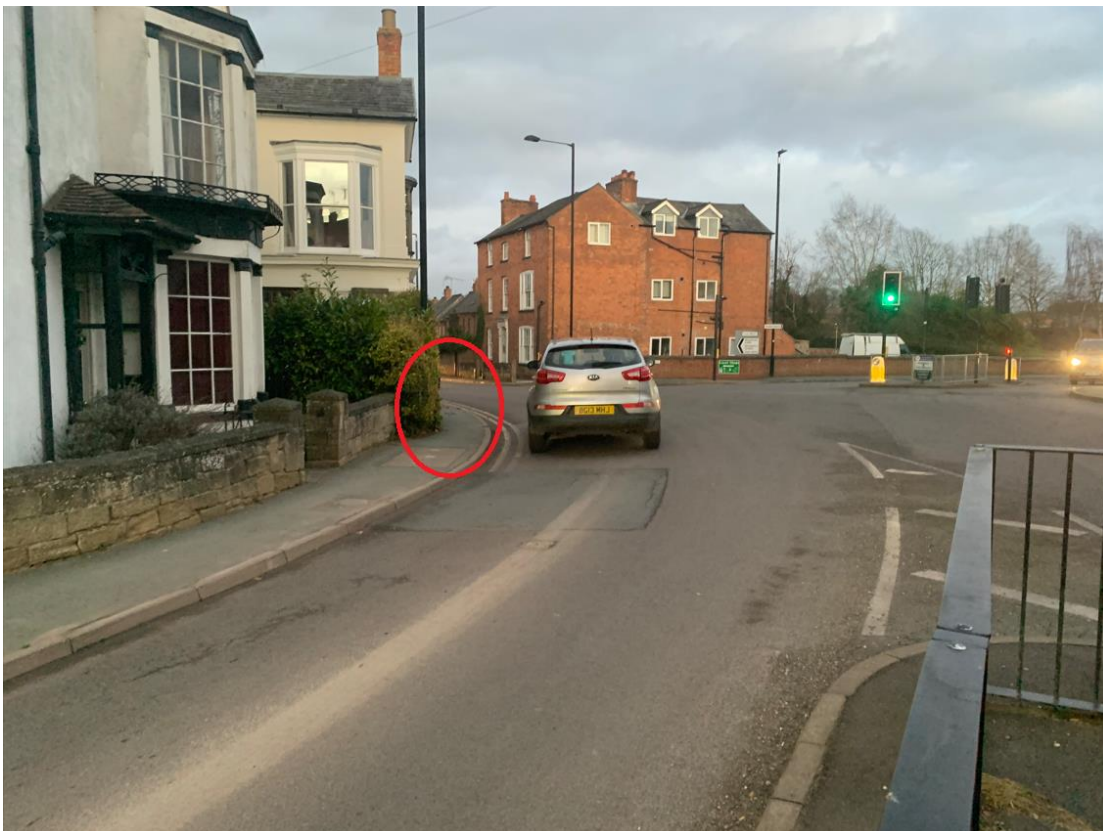
**Location** – Scotland Street/Canal Way junction

**Summary** – Risk of pedestrian/vehicle conflicts due to insufficient room for vehicles to safely pass

The proposed changes to the existing staging of the signalised junction as described in problem 2.6 above, will result in traffic turning right into Canal Way having to give way to traffic approaching from the east. Site observations suggest that the right turn manoeuvre at this junction is popular with drivers accessing the Tesco superstore and the adjacent housing development. No vehicle tracking information has been submitted to the audit team showing how eastbound vehicles heading towards the town centre can pass those waiting in the 'holding area' turning right. In the lack of such information the auditors are concerned that eastbound drivers along the A495 may mount the existing footway, which is very narrow at this point, to pass those waiting to turn right, resulting in pedestrian/vehicle collisions

*The existing footway is very narrow and any changes to the existing junction layout may result in pedestrian/vehicle conflicts*

**Recommendation** – Undertake swept path analysis to make sure that vehicles, particularly HGVs can pass those waiting to turn right. Ensure that the modifications to the existing junction layout do not result in pedestrian/vehicle conflicts

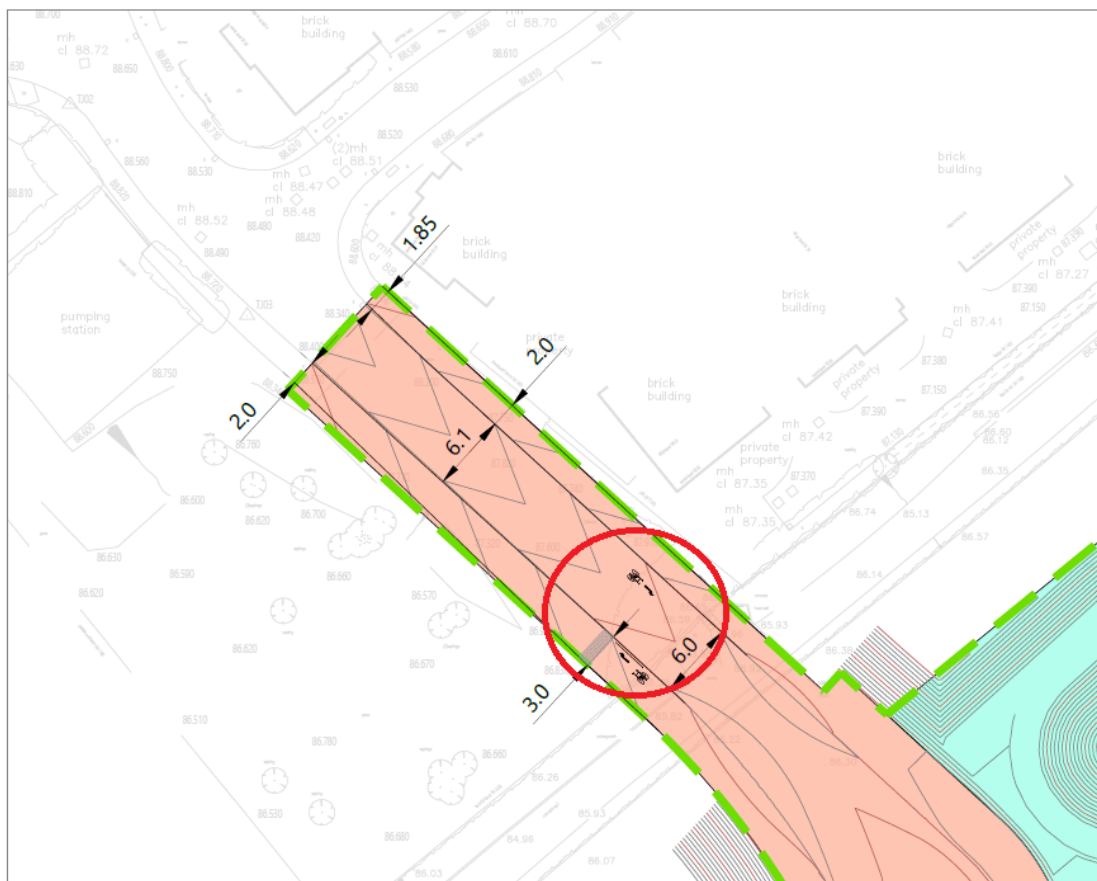
**Location** – Canal Way access to the new development

**Summary** – Risk of cyclist/vehicle collisions due to inadequate cycle transition

Road markings, incorporating a cycle symbol and turn right arrow, are proposed at the new access for cyclists approaching the new development from the northwest to transition onto a proposed shared-use footway on the south-eastern side. This transition creates conflict between road users as cyclists already in the carriageway may not look over their shoulder to turn right onto the shared-use footway and may collide with traffic approaching from behind them. Young, non-confident cyclists whose numbers may well increase following the completion of the new development site, are at a higher risk of conflict

Similarly, northbound cyclists are directed off the shared use path directly into the carriageway, with no physical protection from northbound vehicles approaching from behind them, whose drivers will not be expecting a cyclist to enter the carriageway at this point

*The proposed layout encourages conflicts between cyclists and vehicles*

**Recommendation** – Re-assess the current proposal and ensure that a safer cycle transition is provided, either at this location or elsewhere in the vicinity, to allow cyclists to access, and leave, the proposed shared-use footway safely
